FLIGHT MEASUREMENTS OF LATERAL AND DIRECTIONAL  
STABILITY AND CONTROL CHARACTERISTICS  
OF THE GRUMMAN F8F-1 AIRPLANE

TED NO. NACA 2379

H. L. Crane and J. P. Reeder

Langley Memorial Aeronautical Laboratory  
Langley Field, Va.

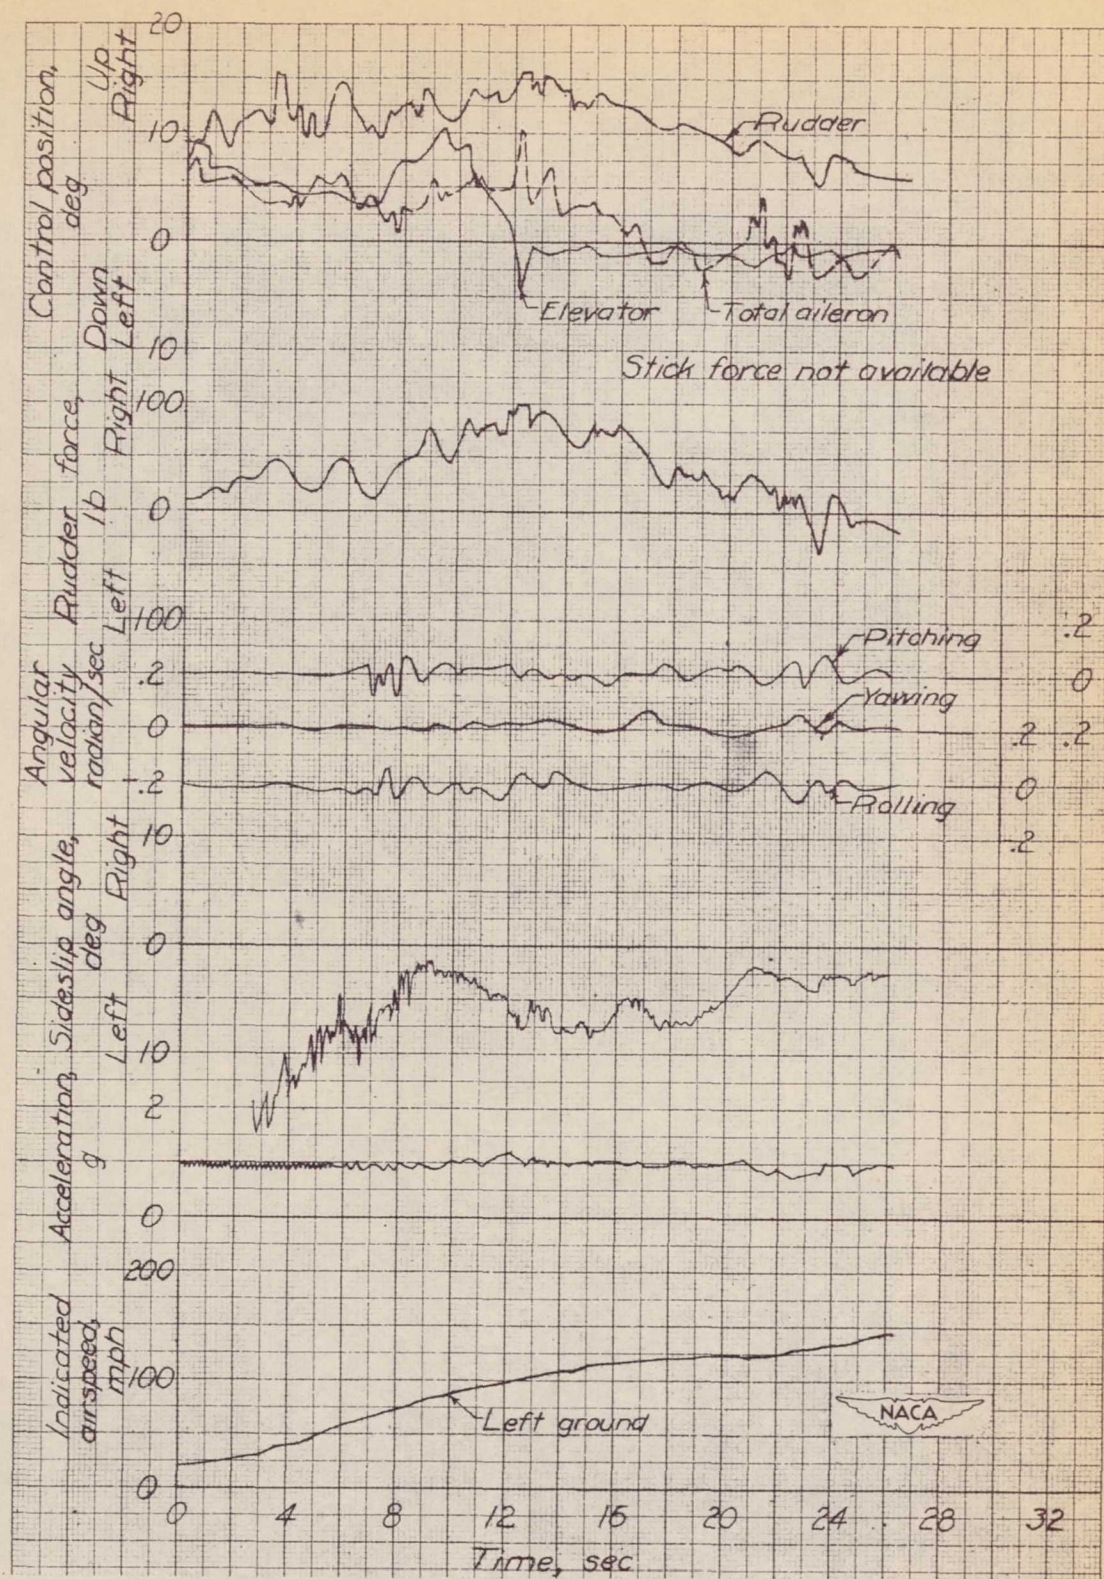
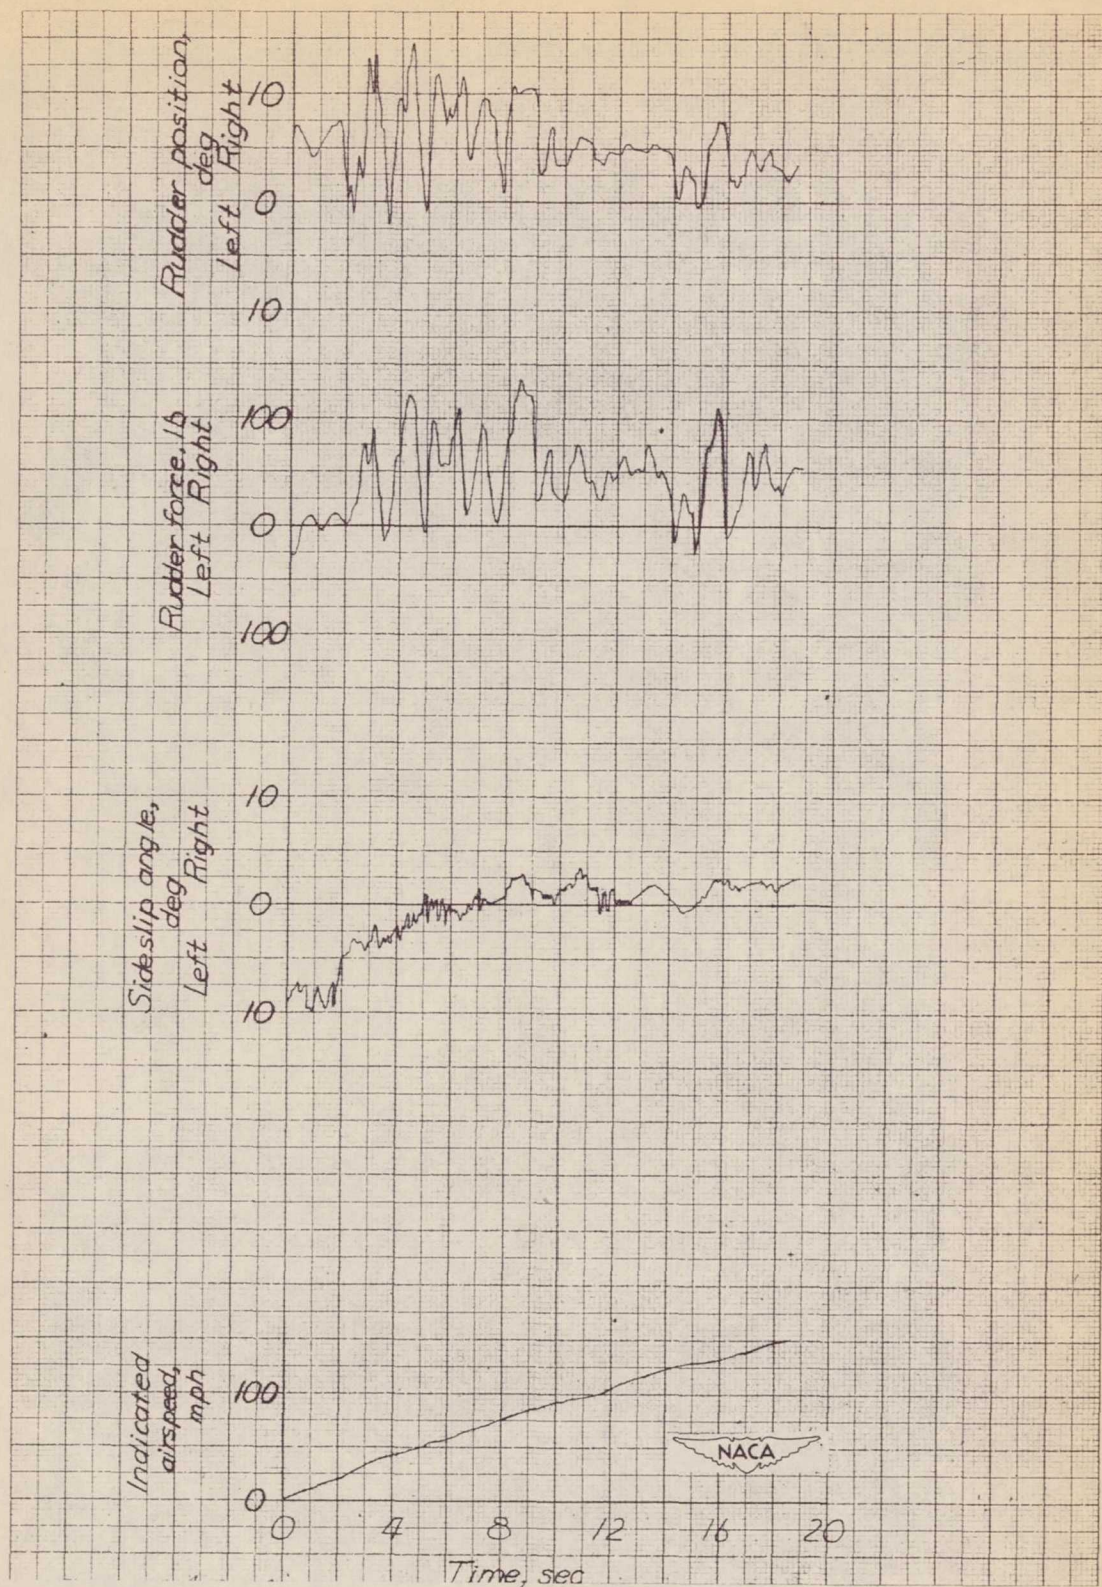
(a) Made by NACA pilot.

Figure 29.- Time histories of take-offs, F8F-1 airplane with tail configuration 3.

(b) Made by service pilot. (Elevator and aileron records eliminated for clarity.)

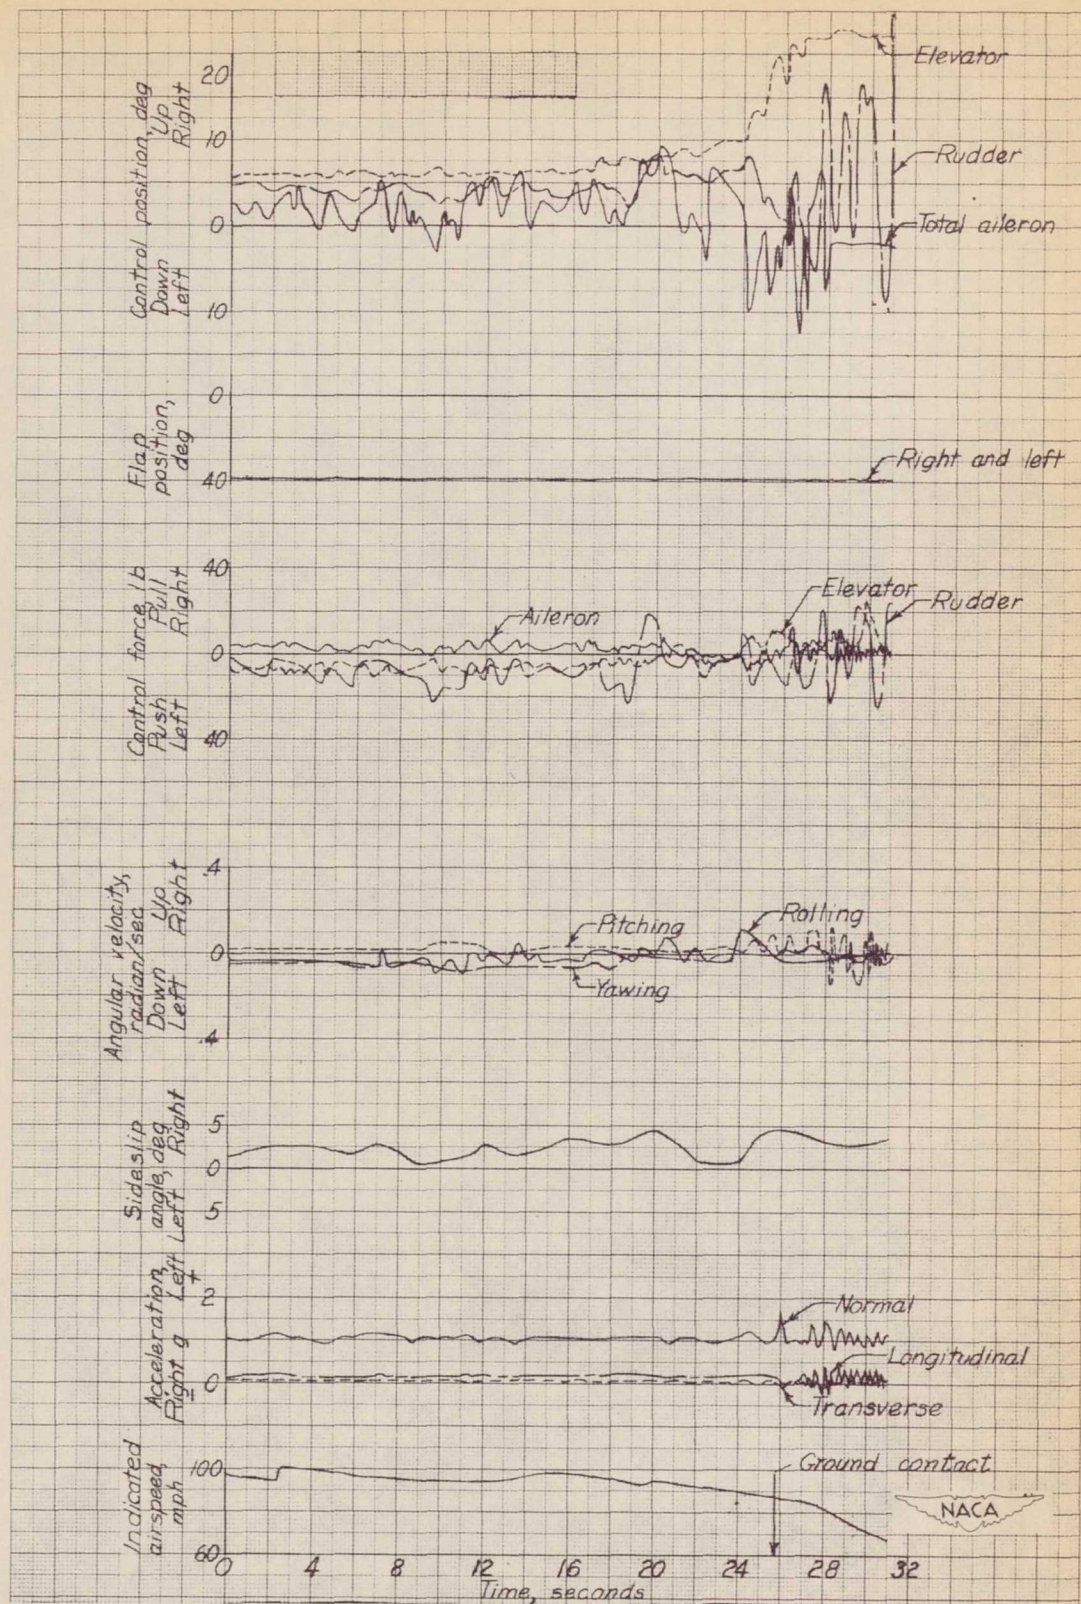
Figure 30.- Time history of simulated carrier landing (22 in. Hg, 2400 rpm), F8F-1 airplane, with tail configuration 1, made by service pilot.

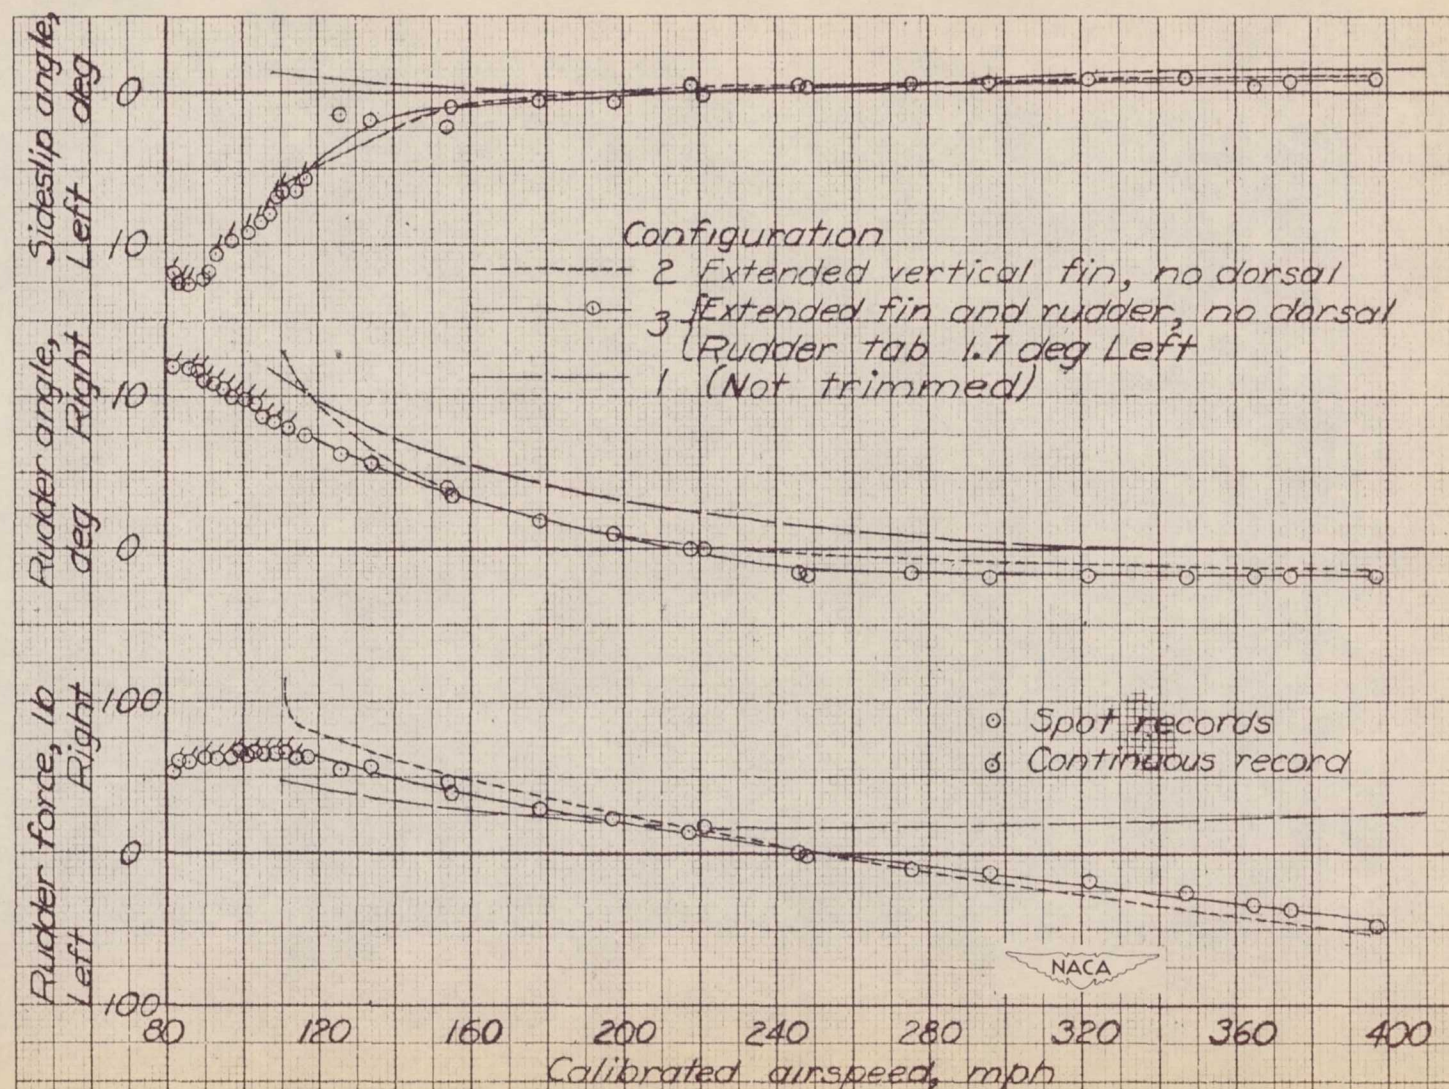
Figure 31.- Directional trim characteristics in the rated-power, clean condition (41 in. Hg at 2600 rpm), with three vertical tail configurations, F8F-1 airplane.

Figures 31 and 32 present the variation of directional trim characteristics over the test speed ranges in the rated-power clean, and the wave-off conditions for all three tail configurations. The change of rudder force with speed between the stall and a speed of 400 miles per hour in the rated-power clean condition for a trim speed of 250 miles per hour was approximately 60 pounds with tail configuration 1 (calculated from the data of fig. 31), 160 pounds with tail configuration 2, and 110 pounds with tail configuration 3. The rudder-force change with speed satisfied the Navy requirement for diving flight. However, a desirable reduction in the force variation with speed could be effected by use of a springy tab.

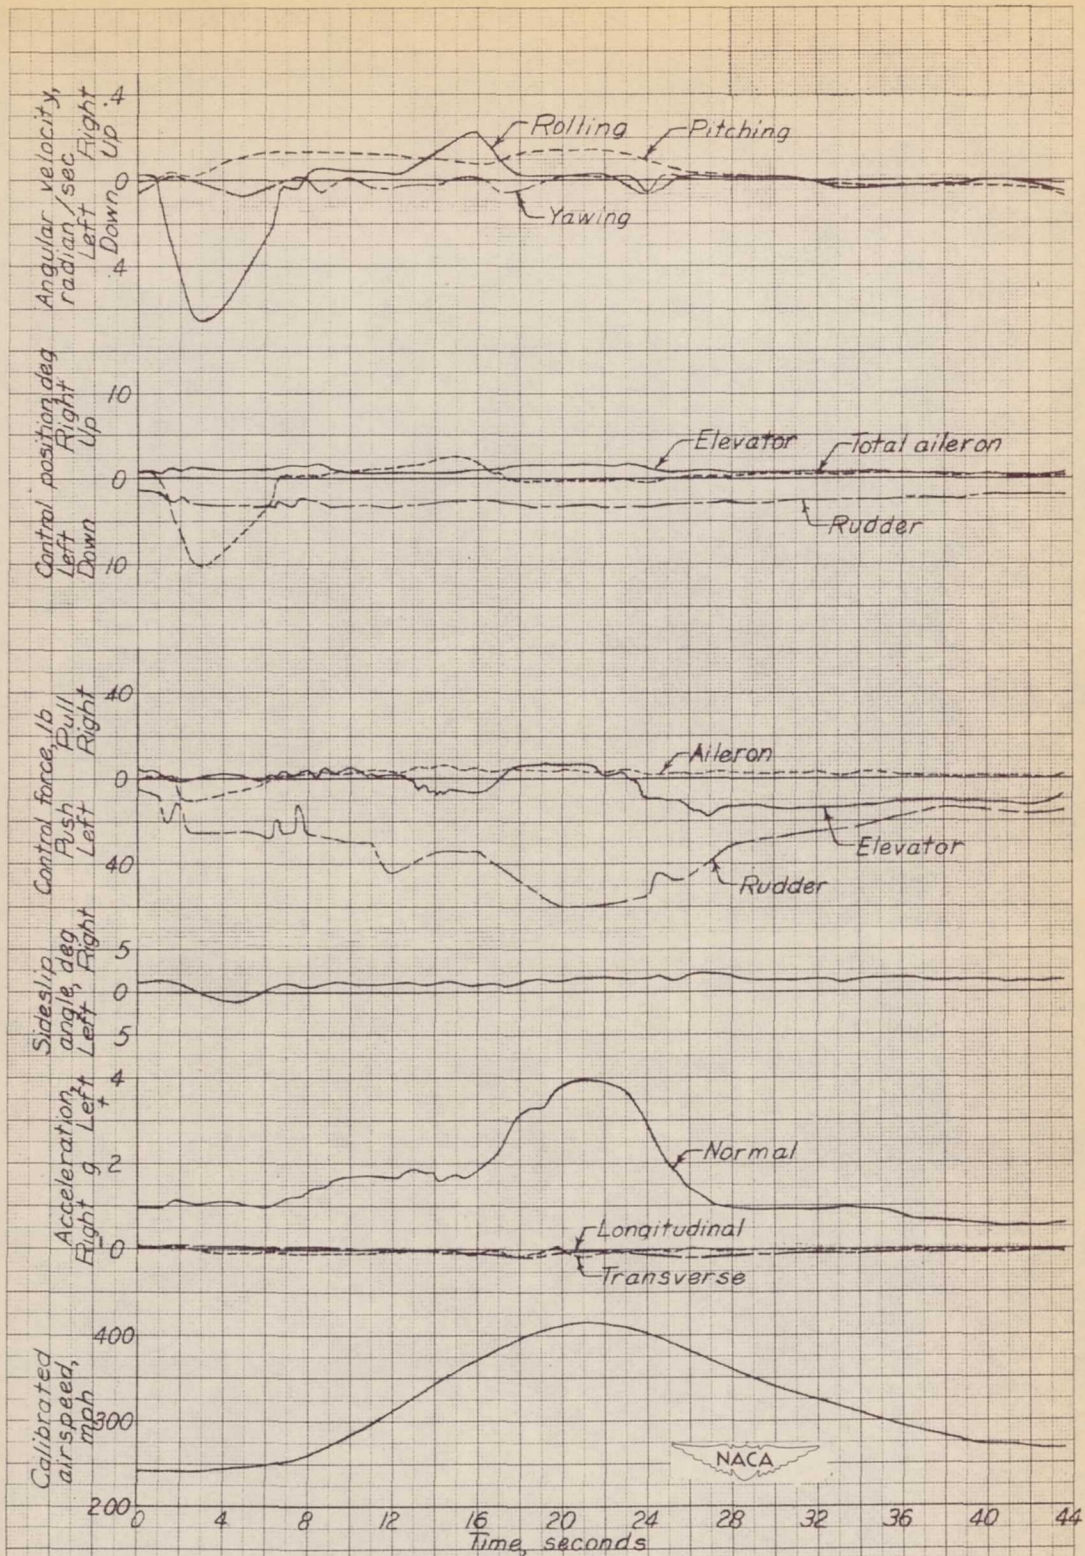
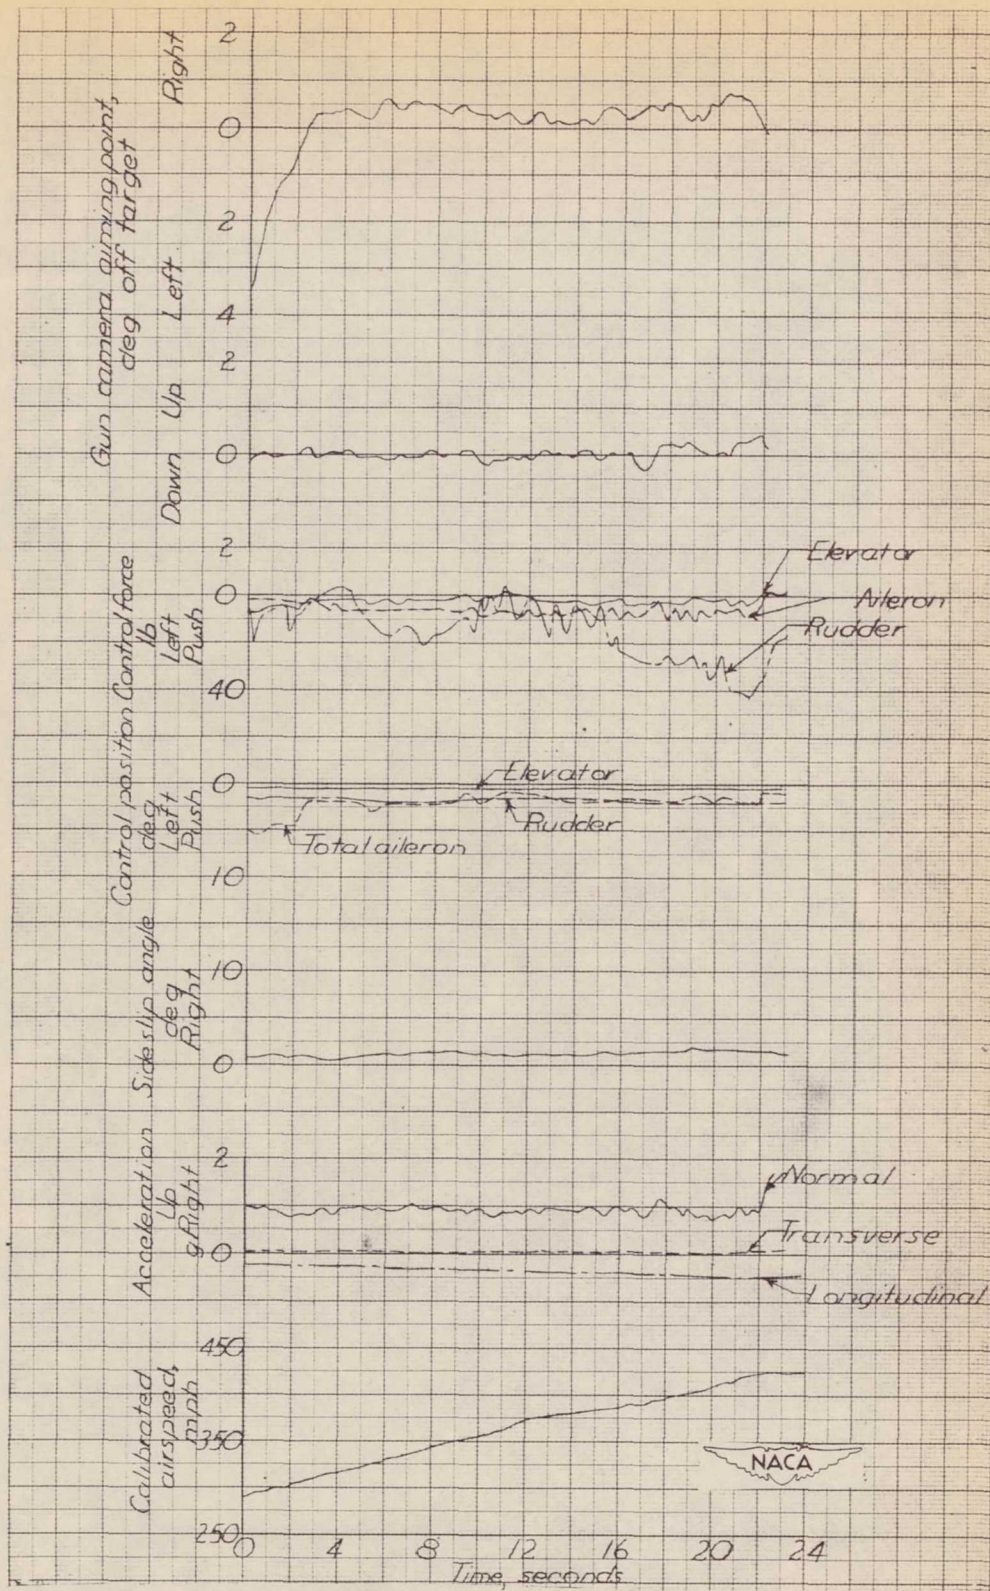
(a) With tail configuration 1, made by service pilot.

Figure 33.- Time histories of strafing runs, F8F-1 airplane with belly tank on, oil coolers closed.

(b) With tail configuration 3, made by NACA pilot.

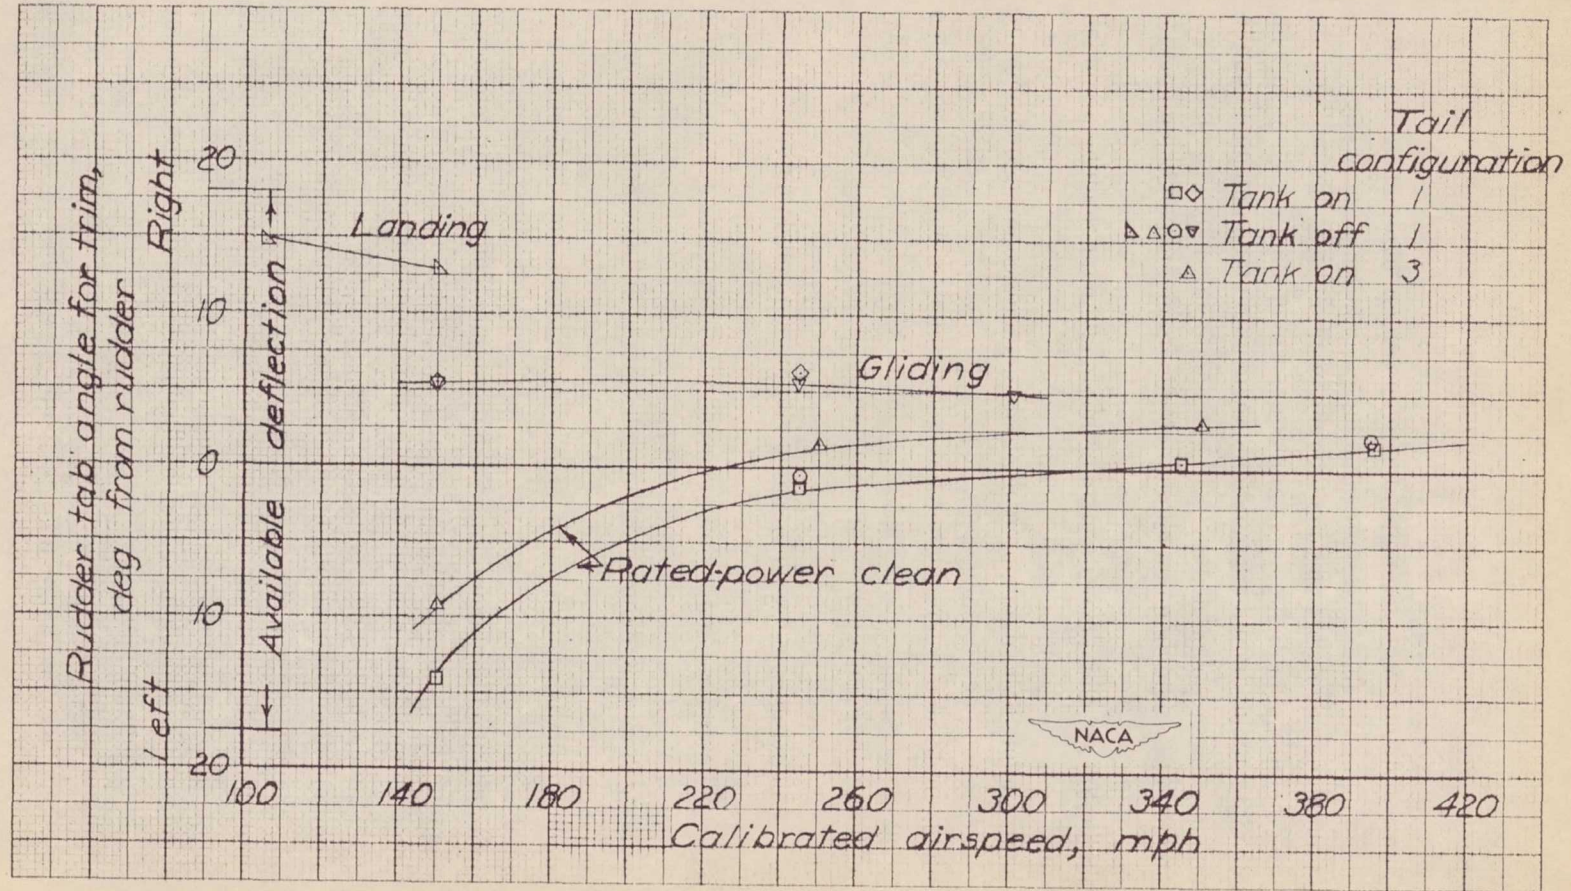
Figure 34.- Variation of rudder tab angle for trim with airspeed, F8F-1 airplane.

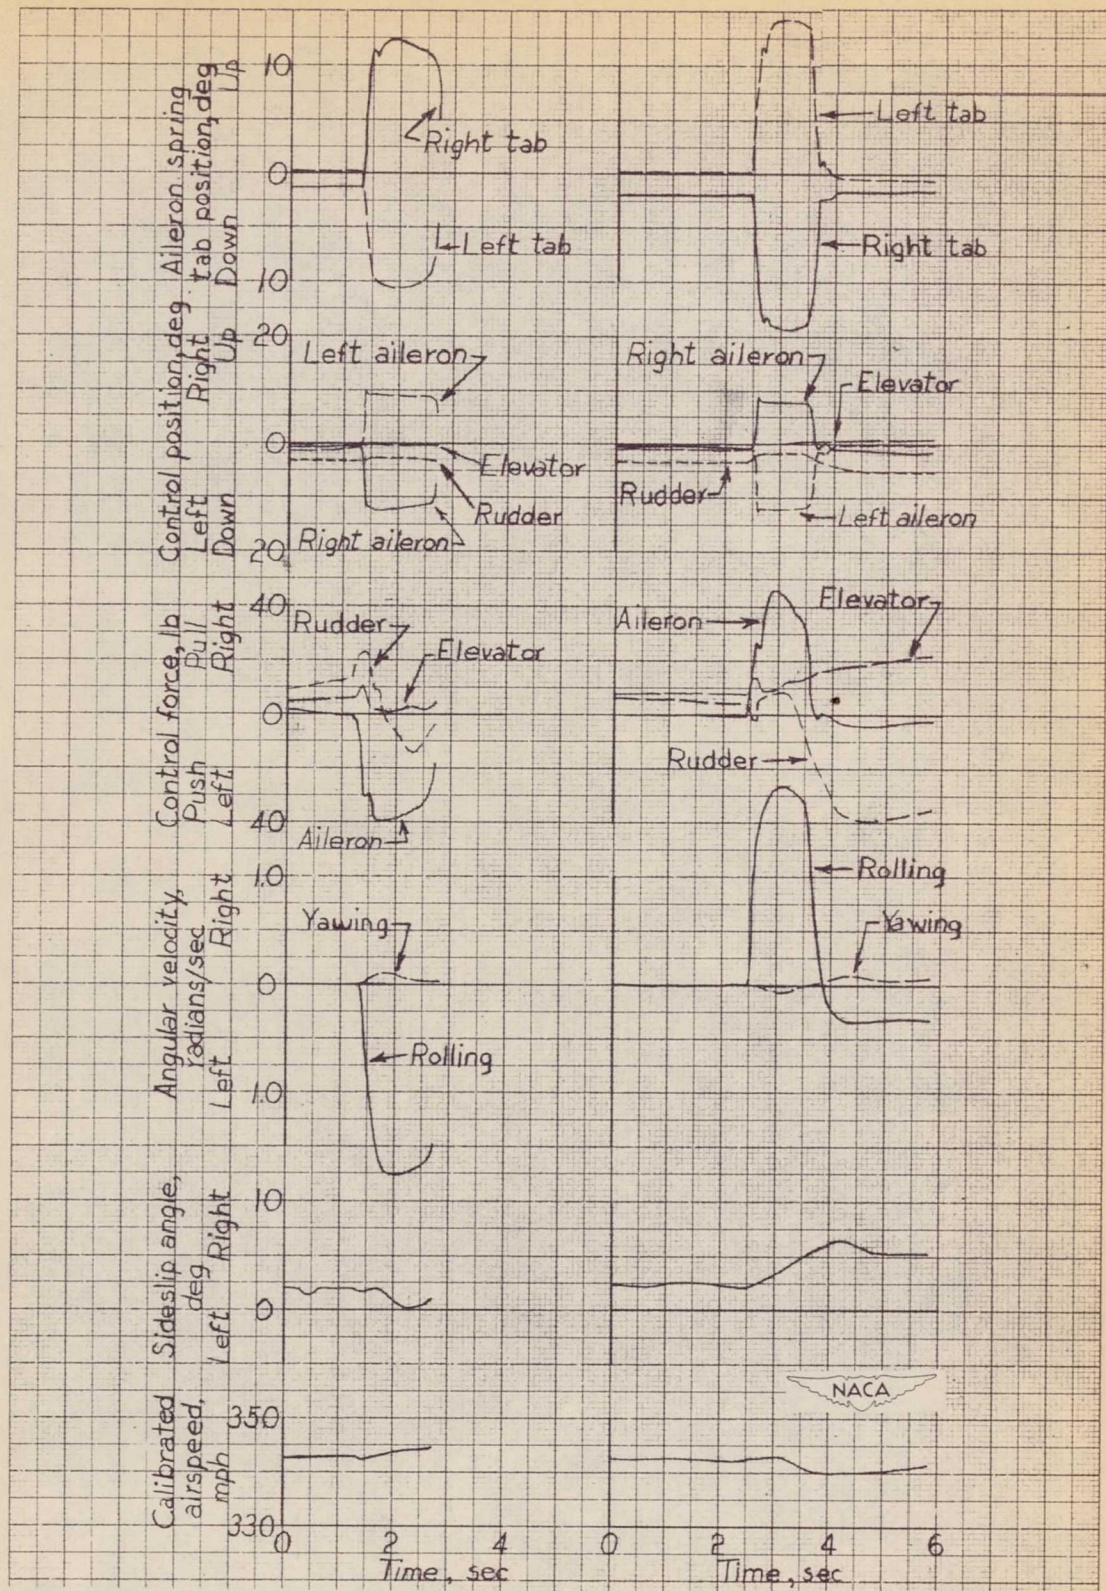
(a) Left roll.

(b) Right roll.

Figure 35.- Time histories of rolls at approximately 340 miles per hour, rated power, flaps and gear up. F8F-1 airplane.

Figure 35 presents time histories of typical aileron rolls obtained at 340 miles per hour in the rated-power, clean condition. The variation of rolling effectiveness and control force with total aileron deflection are presented in figure 36 for each flight condition and speed investigated. Figure 37 shows the variation of right-aileron spring-tab angle with right-aileron deflection in aileron rolls with power for level flight in the clean condition at speeds from 148 to 397 miles per hour. The variation with airspeed of rolling velocity at 10,000 feet, total aileron angle, and helix angle  $pb/2V$  for a control force of 30 pounds and for full stick deflection is presented in figure 38. The variation of lateral trim force with speed is given in figure 39.

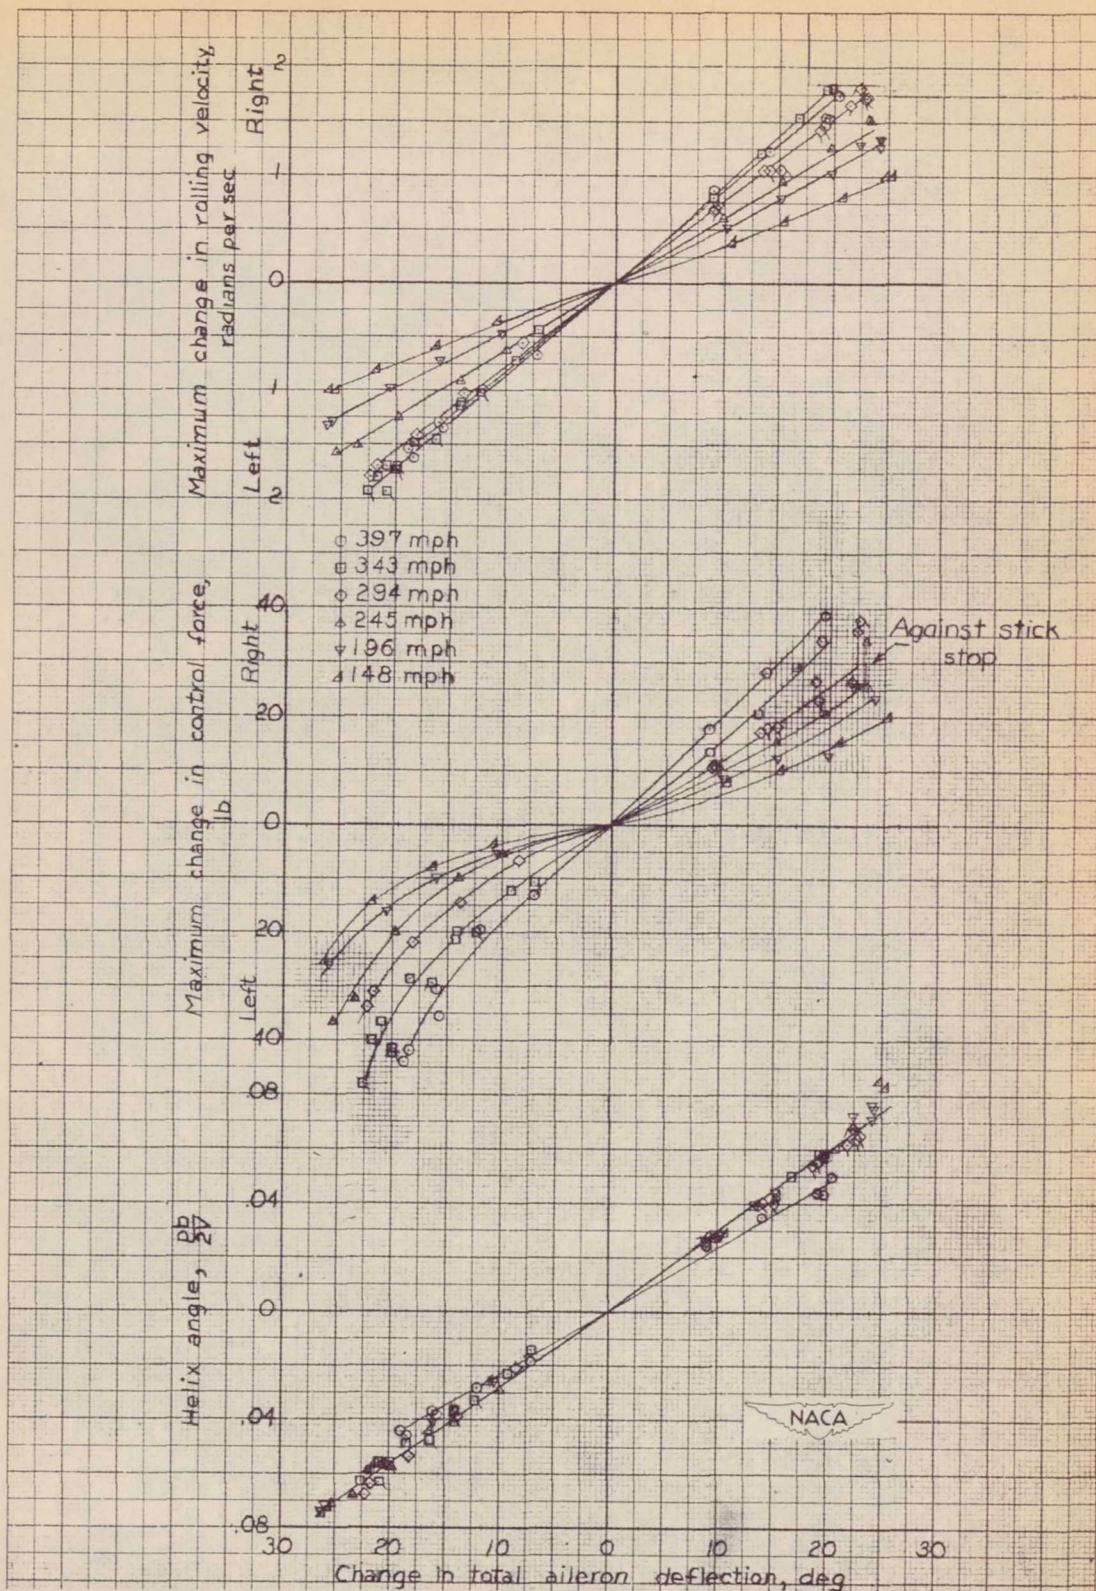
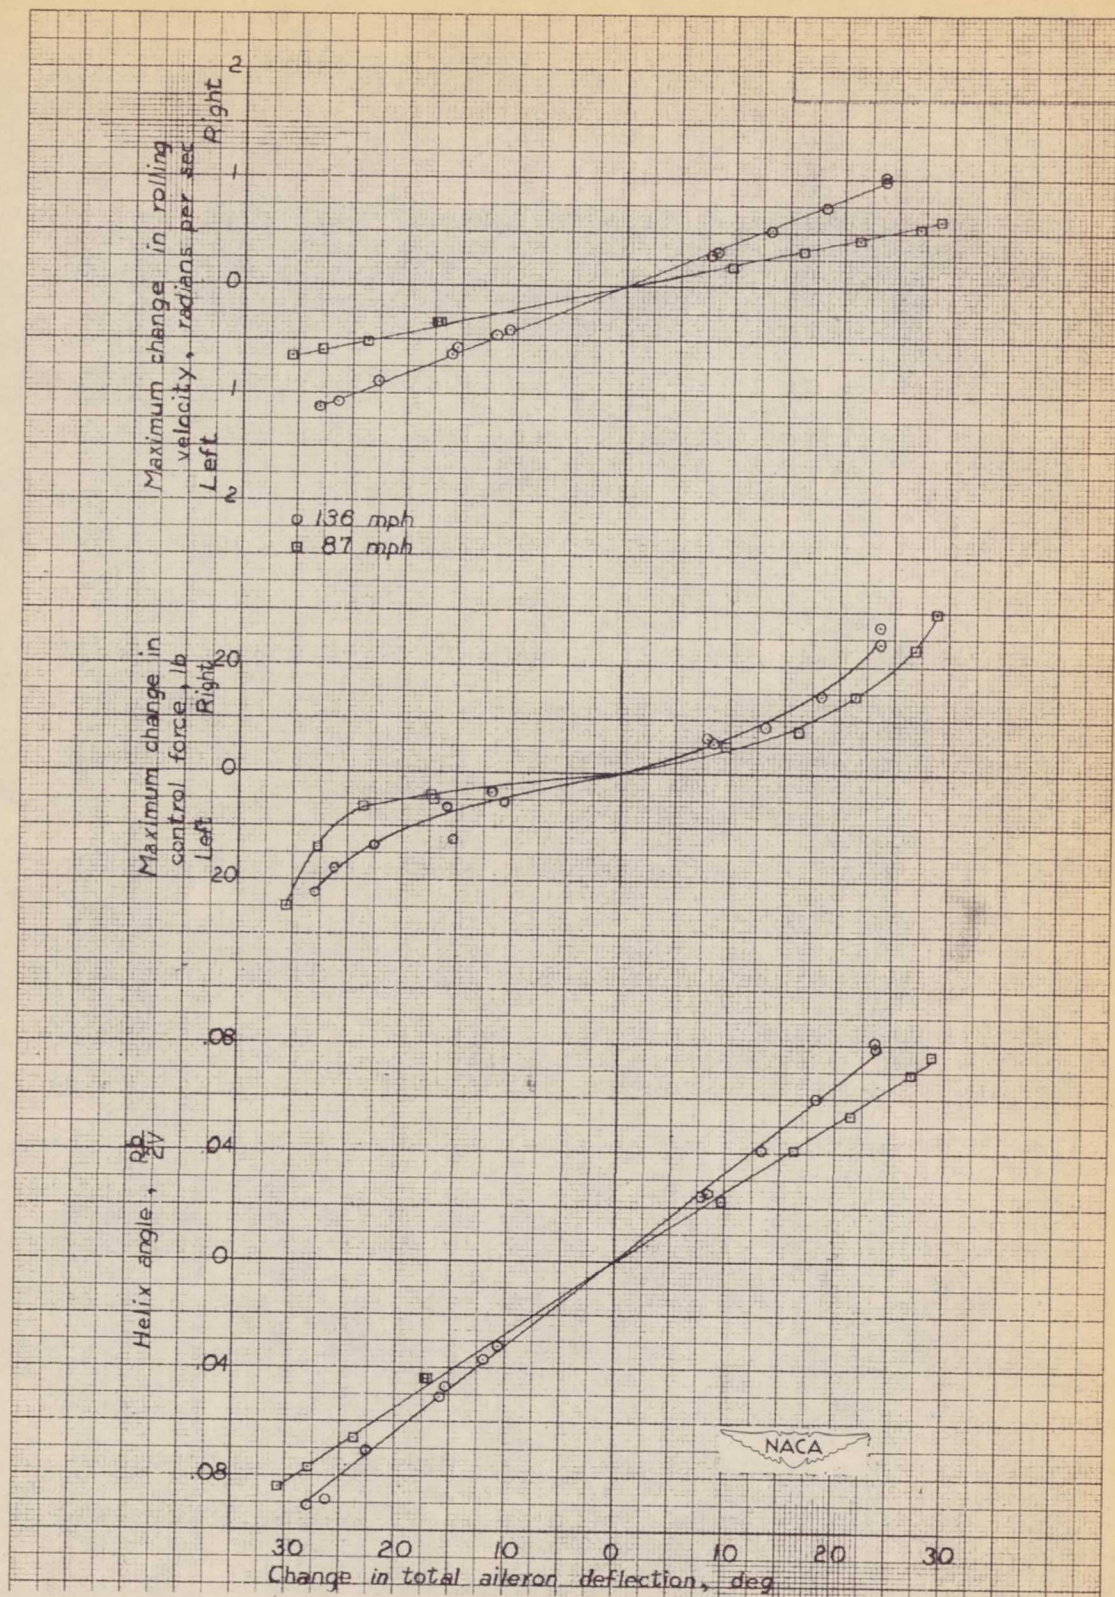
(a) Power for level flight, flaps and gear up.

Figure 36.- Aileron characteristics in rolls at 5000 feet, F8F-1 airplane.

(b) Power for level flight, flaps and gear down.

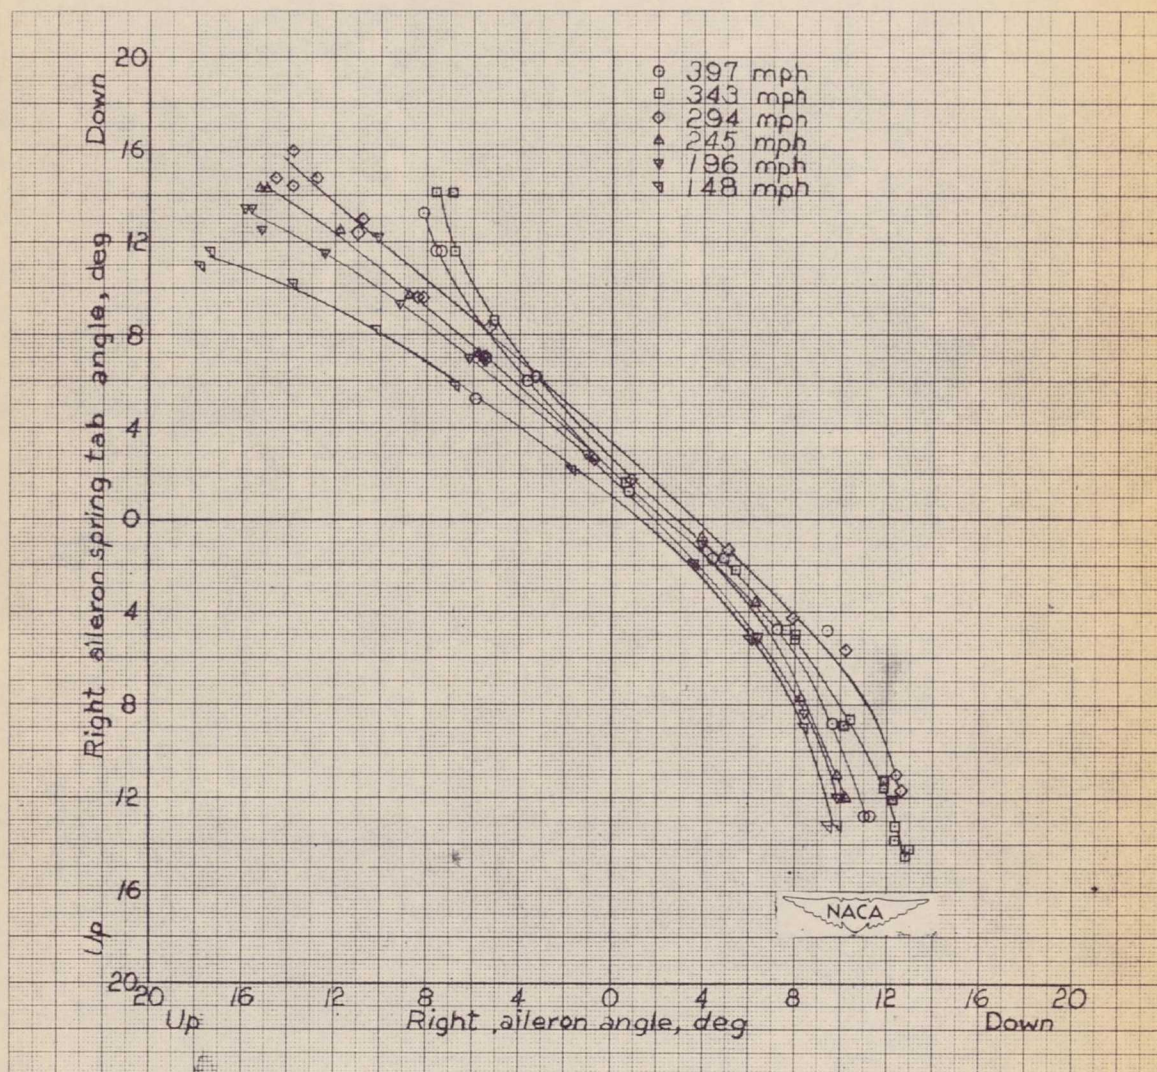
Figure 37.- Variation of right aileron spring tab angle with right aileron angle. Power for level flight, flaps and gear up. F8F-1 airplane.

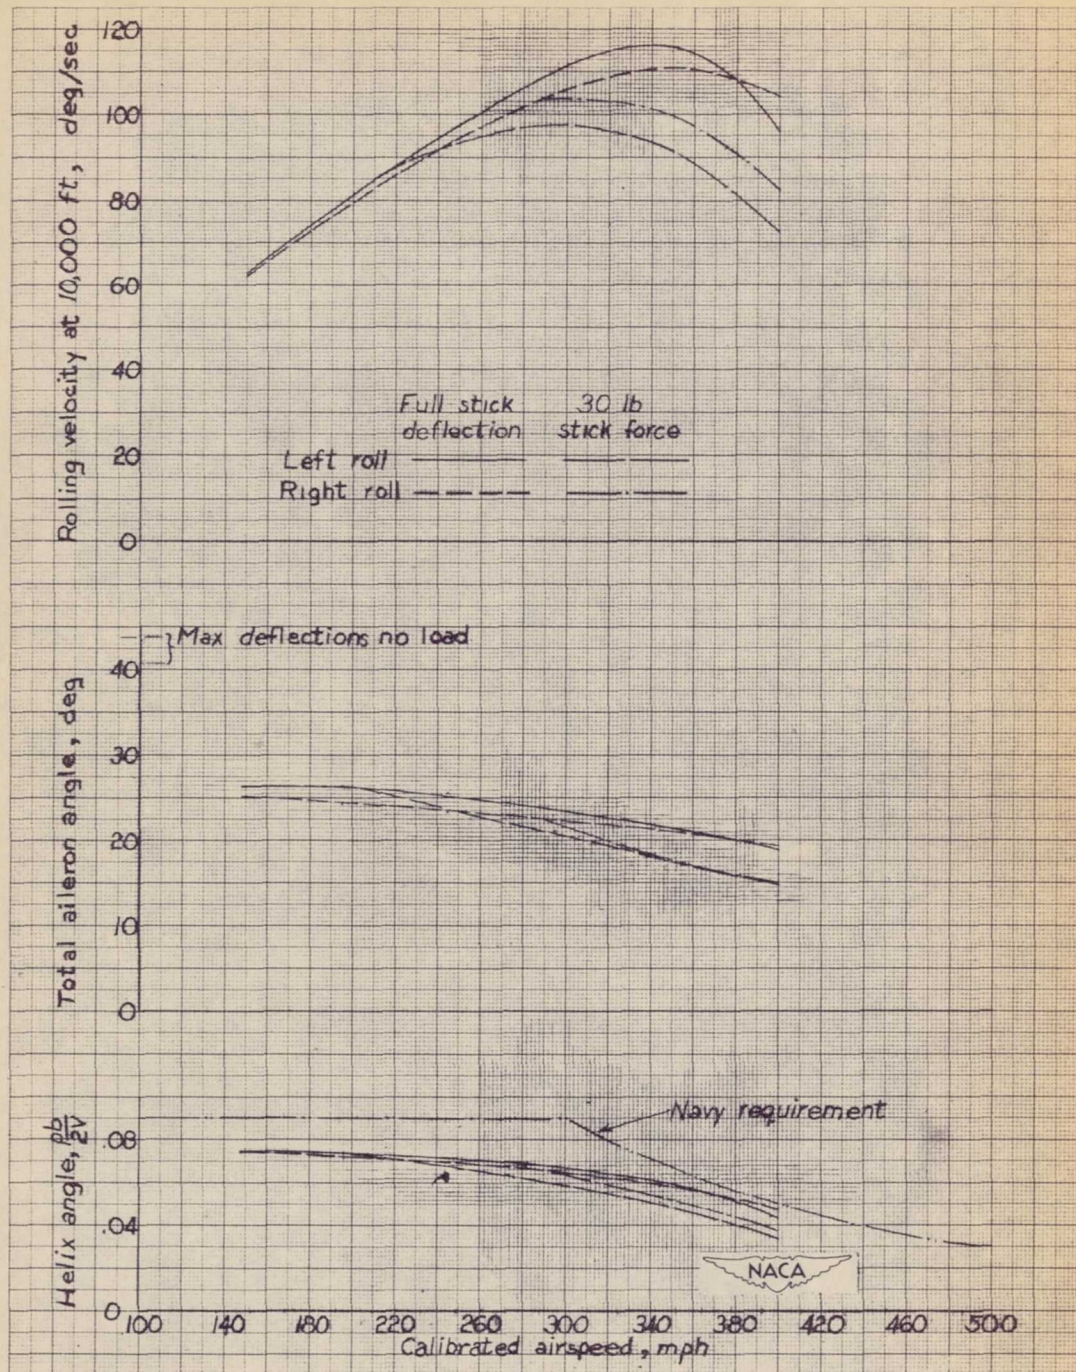
Figure 38.- Variation of rolling velocity at 10,000 feet, total aileron angle, and helix angle with indicated airspeed, power for level flight, flaps and gear up. F8F-1 airplane.

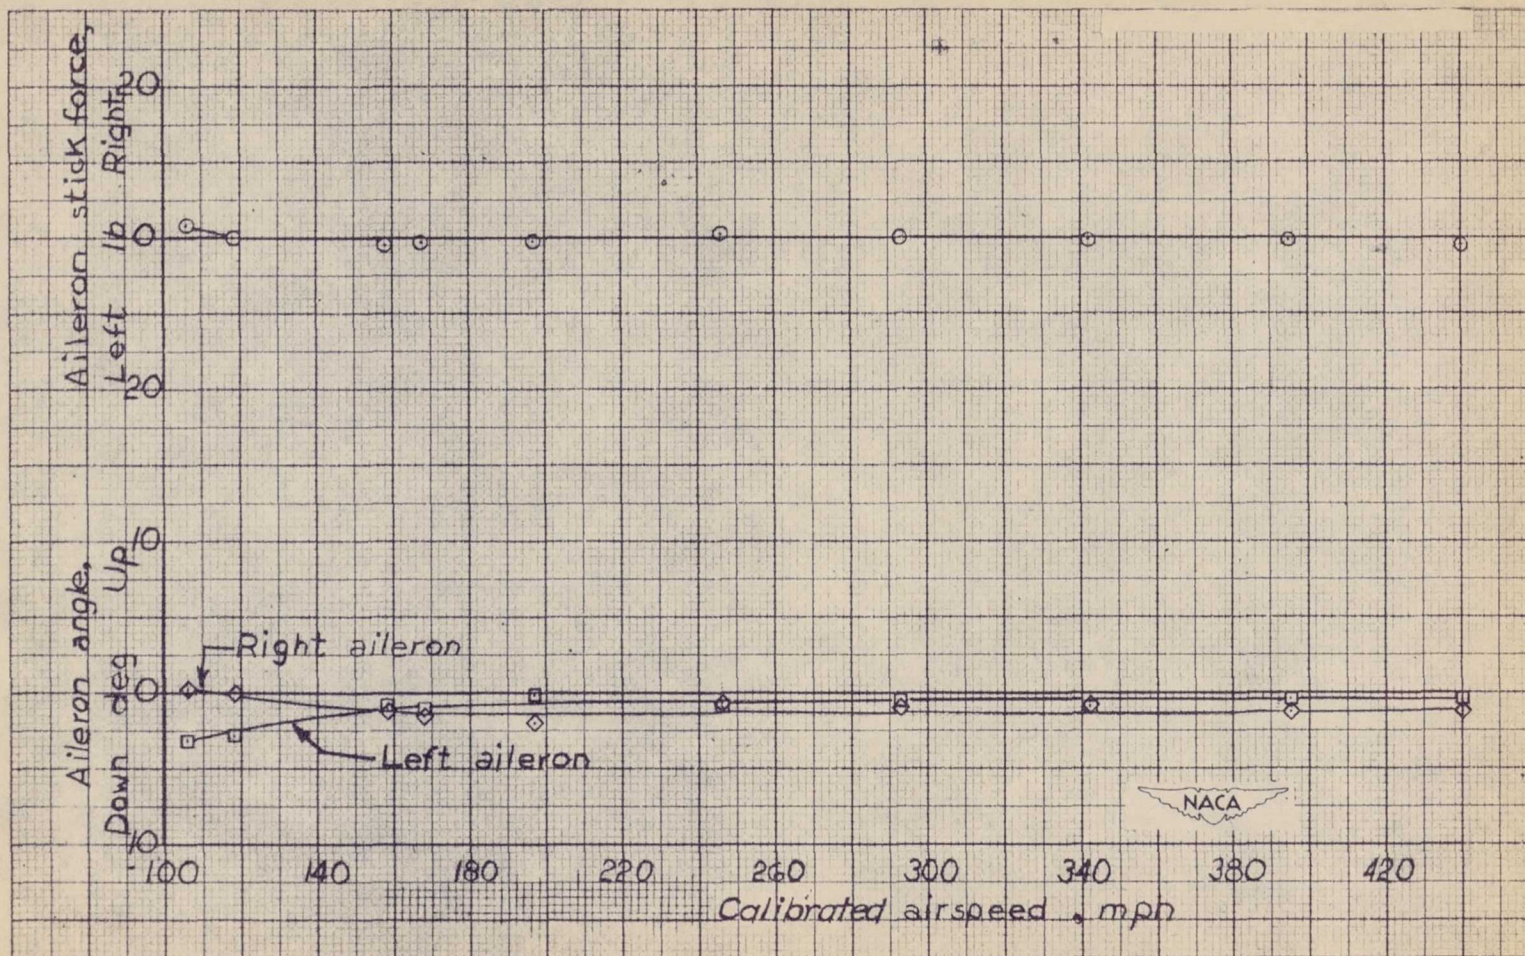
Figure 39.- Variation of aileron stick force and aileron angle with indicated airspeed, rated power, flaps and gear up, F8F-1 airplane (90461).

(g) Figure 39 indicates that the variation of aileron trimming force with speed was small. The aileron trimming tab was found to be adequate.
